Summary report of the turboprop test
chamber acceptance tests conducted on 27
April to 8 May 1964

U. S. NAVAL POSTGRADUATE SCHOOL
Astro/Aeronautical Propulsion Laboratories

SUMMARY REPORT
of the
TURBOPROP TEST CHAMBER ACCEPTANCE TESTS
Conducted on
27 April to 8 May 1964

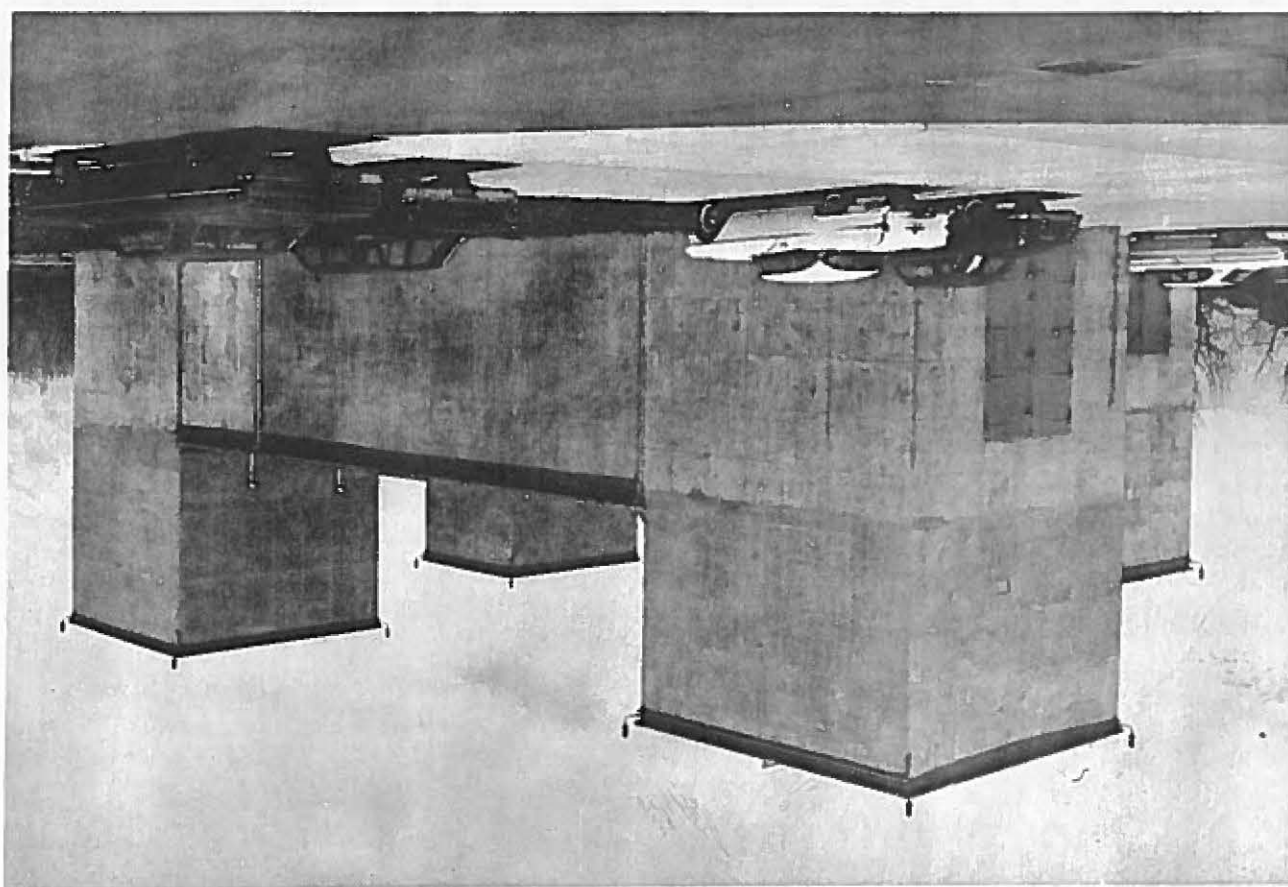
Figure No. 2

During the installation of the engine support stand and the engine, portable work platforms were utilized along both sides of the engine thrust stand, as shown in Figure 2. These units had to be partially disassembled, locked and tied together along the chamber wall during engine operation. Thus any engine adjustment during the tests required that the personnel climb the side of the engine thrust stand and the support stand. This hazardous condition should be eliminated by installation of permanently installed access platforms surrounding the thrust stand. In addition, an expanded metal grating should be placed beneath the thrust stand to protect personnel from falling objects.

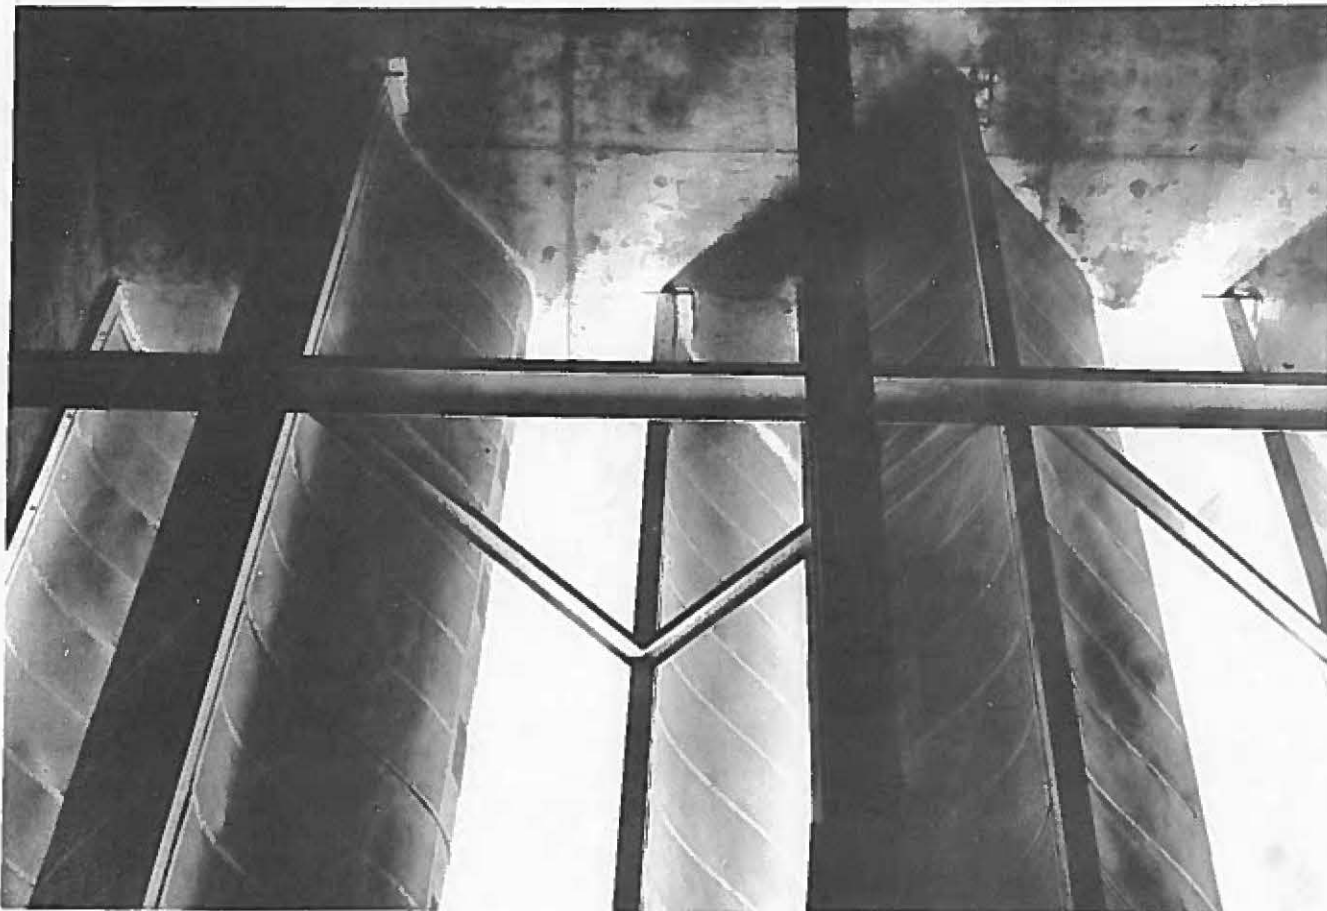
Figure No. 16

(d) Acoustic Survey. The inlet and exhaust acoustic installations, shown in Figure 16, performed satisfactorily. The Sound Pressure Levels recorded along a 250 foot radial arc slightly exceeded the limits specified in reference (d). The predominance of strong gusty winds contributed greatly to the SPL levels recorded. The acoustic survey of the double doors in the front of the test chamber indicated that further adjustment of the door will be required to realize the required SPL reduction of 45 db. The vibrating movement of the doors along with the centerline and especially at the center section appeared to be excessive.
